WOODS HOLE OCEANOGRAPHIC INSTITUTION
Woods Hole, Massachusetts

REFERENCE NO. 69-36

ANALYSIS & EXPERIMENTAL EVALUATION
OF
SINGLE POINT MOORED BUOY SYSTEMS

TECHNICAL REPORT

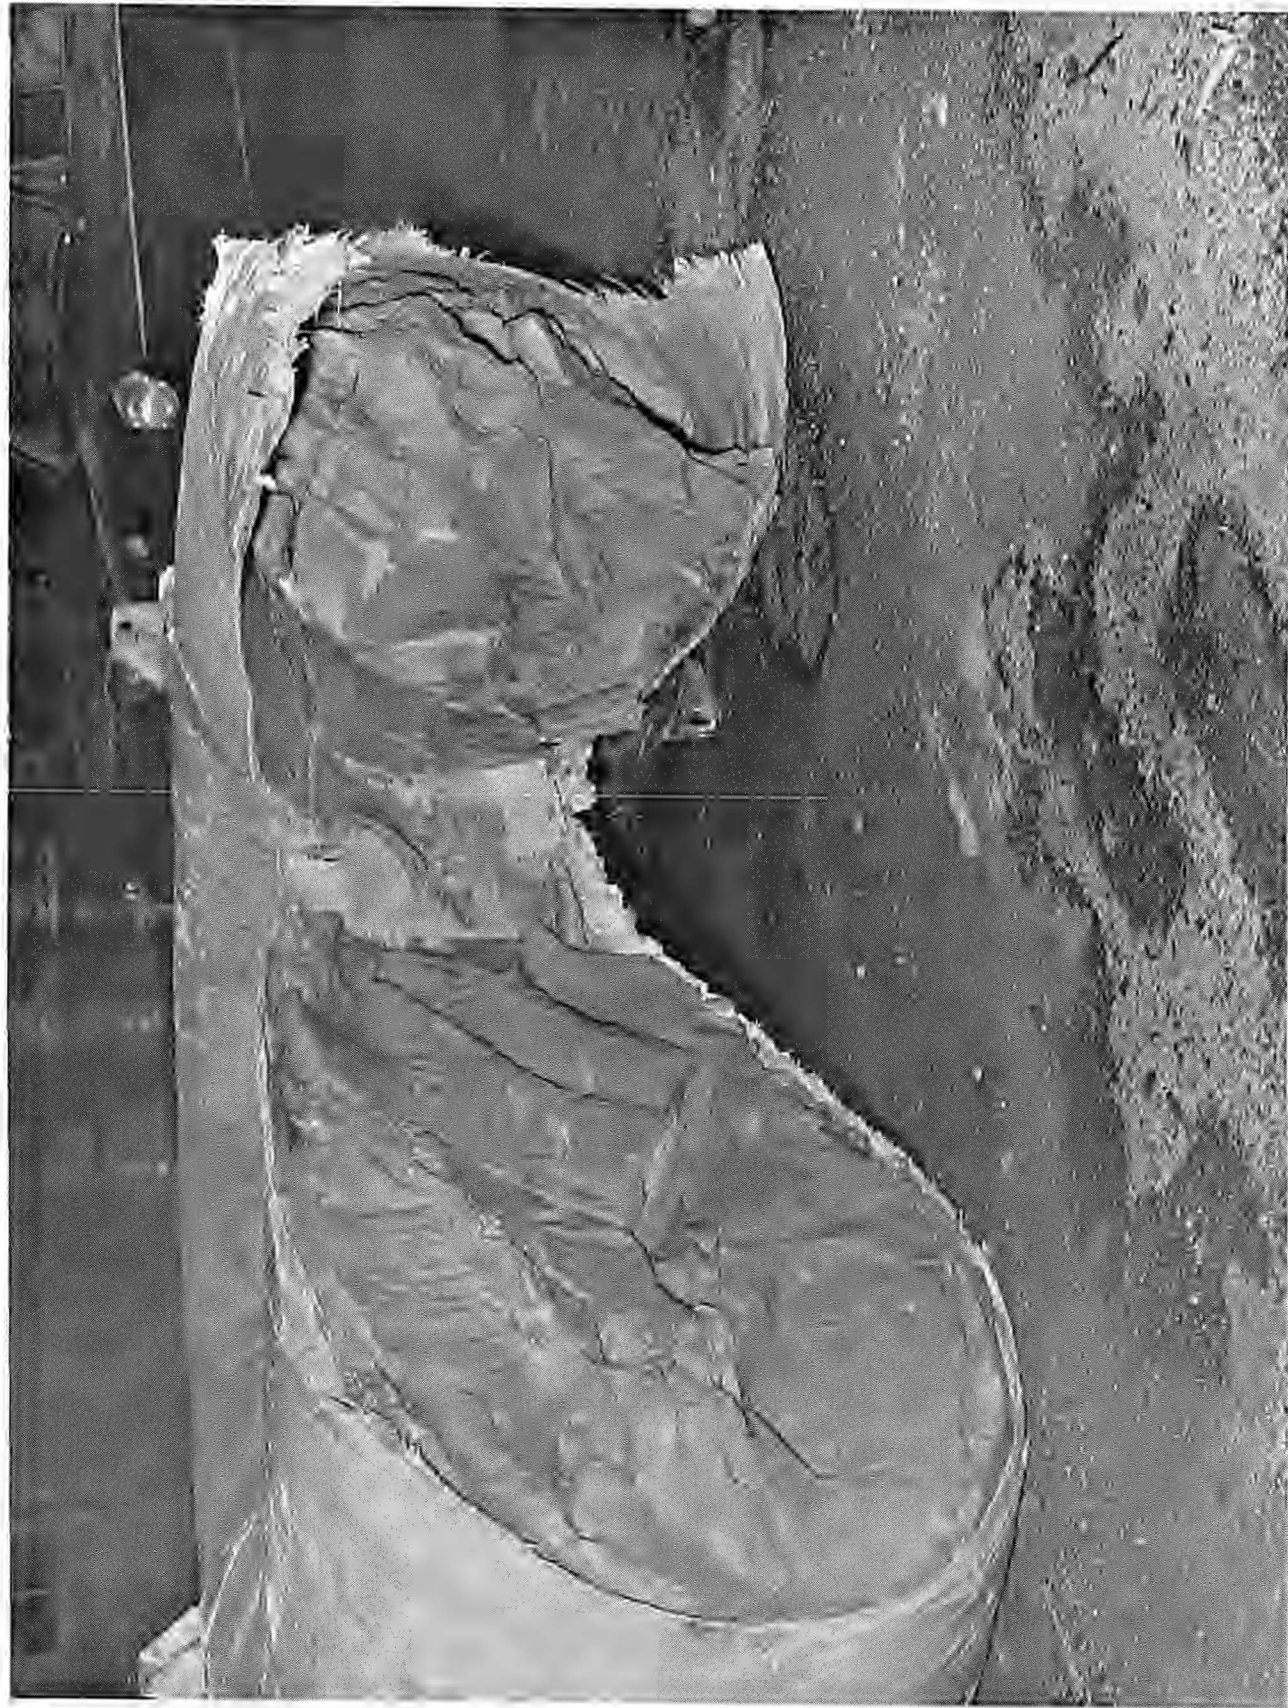
Figure 28. ALVIN Inspection Mooring Buoy After Recovery

vessel (Tanker Benoil) picked up the surface buoy with the tension recorder still intact, approximately 100 miles south of its' original position. The tower was missing and one third of the toroid was cut away. (See Figure 28). The shape of the cut and the abrupt increase of tension beyond full scale (>3000 pounds) noted on the record, clearly indicate that the buoy was run down by a vessel and was caught in her screws. The tension record shows that the collision occurred at 0300 on October 21, 1968.
